NASA TN D-5156

EXPERIMENTAL BENDING STRENGTH OF AN ATLAS LV-3C BOOSTER BEYOND COMPRESSIVE SKIN WRINKLING

by Robert P. Miller

Lewis Research Center Cleveland, Ohio

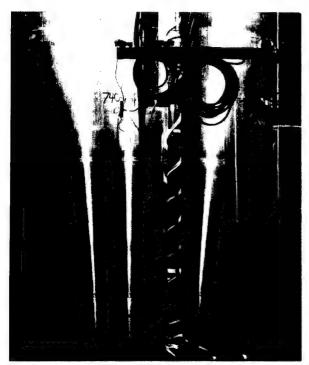
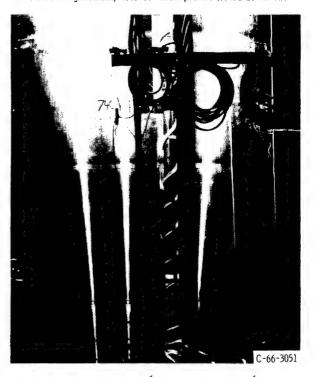
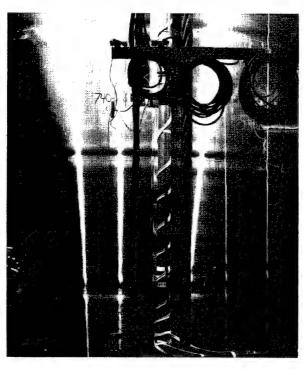
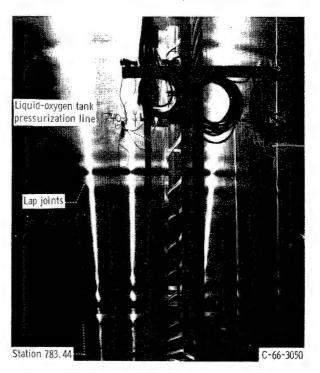
As the moment was increased beyond the onset of skin wrinkling the buckles appeared as damped sinusoidal waves propagating from the lap joint areas and progressing toward the middle portion of the tank skins (see fig. 14). The profile of the tank surface at the extreme compression fiber is shown in figure 15 under the influence of several test 1 loading conditions.

Figure 14. - Wrinkle patterns for test 1. Axial load, 75 800 pounds (336 000 N).

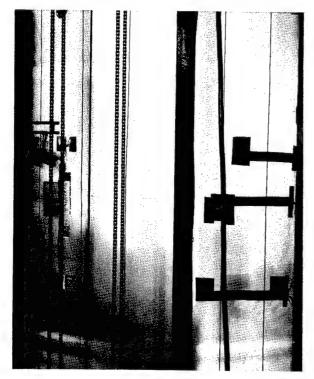
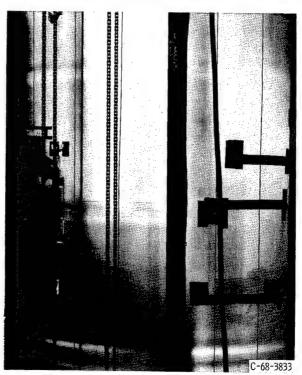
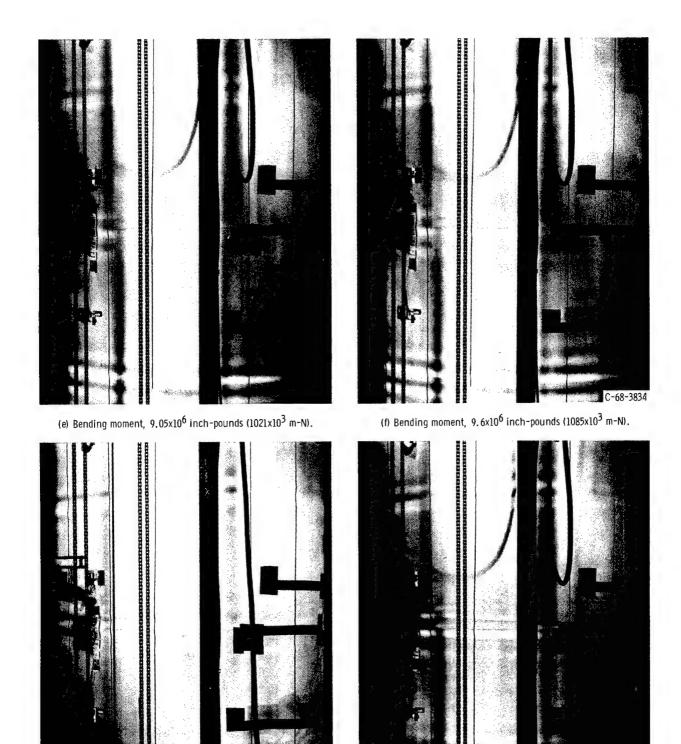
Test 2 was terminated when static equilibrium could no longer be maintained, and all loads were immediately removed to prevent destruction of the test vehicle. Typical wrinkle patterns observed during test 2 are shown in both figures 20 and 21. In figure 21, skin wrinkling can be observed under the wiring tunnel. The presence of the tunnel had no apparent effect on the wrinkling pattern nor was any damage to the tunnel and its attachments observed.

Figure 21. - Closeup of wrinkle patterns - test 2.

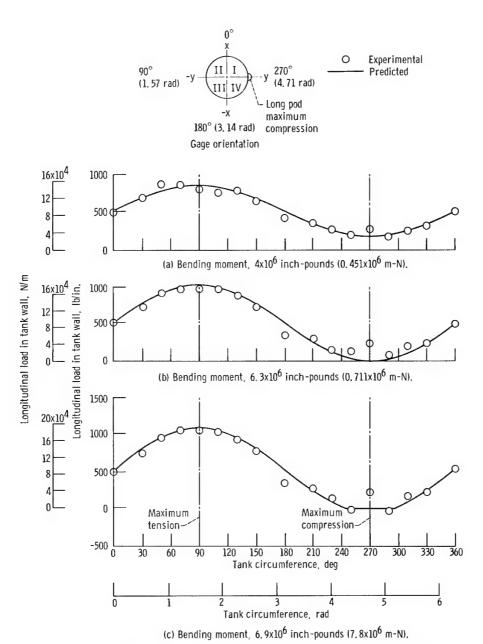
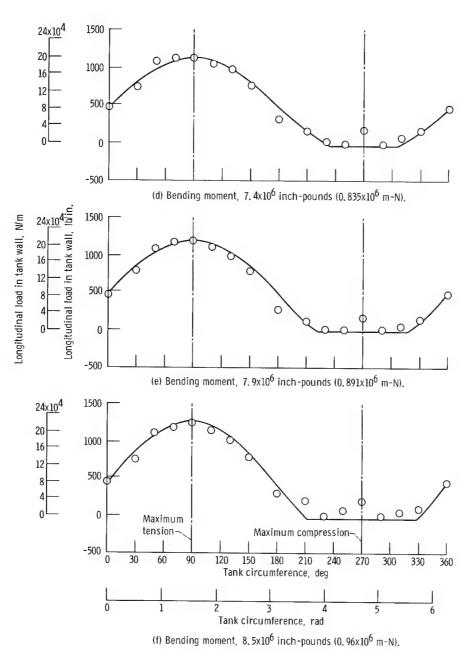
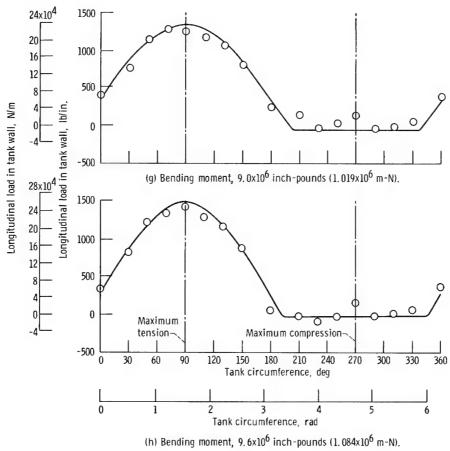
Figure 27. - Measured load distribution around circumference of Atlas at station 584 compared with predicted - test 3. (Flat portion of curves indicates portion of tank skin that has wrinkled.)

Figure 27 shows the load distribution around the tank circumference in the middle of the 0.014-inch- (0.000356-m-) thick skin just below station 570 during test 3. The curves show predicted longitudinal load against tank circumference compared with strain-gage test data. The element of the tank circumference at the  $270^{\rm O}$  point received maximum compression. As the moment increased from 6.3×10<sup>6</sup> to 6.9×10<sup>6</sup> inch-pounds  $(0.71\times10^6 \text{ to } 0.78\times10^6 \text{ m-N})$ , wrinkling of the skin began, as indicated by the flat portion of each load curve in figure 27. The length of the flat portion describes the extent of wrinkling around the circumference. The curves indicate that the wrinkle angle progresses from about  $52^{\circ}$  at 6.9×10<sup>6</sup> inch-pounds (0.78×10<sup>6</sup> m-N) to  $152^{\circ}$  at 9.6×10<sup>6</sup> inchpounds (1.085×10<sup>6</sup> m-N). These strain-gage data, in general, agree with the predictions and confirm the similar data evaluated in test 1 (fig. 16). The loading of test 3 placed a maximum tensile load of 1534 pounds per inch (268 000 N/m) and a maximum compressive load of 910 pounds per inch (159 000 N/m) on the ring at station 570. At the conclusion of test 3, close visual inspection of the test vehicle revealed no evidence of yielding or damage to the tank skins, the ring at station 570, the area around station 960 (intermediate bulkhead junction), or the interstage adapter. A soapbubble check at

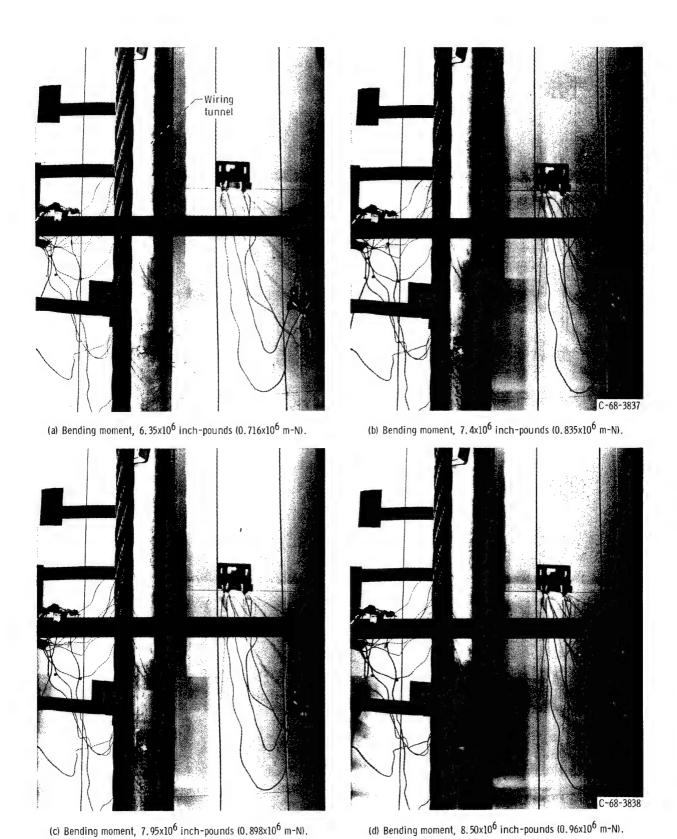
Skin wrinkling that occurred near, or under, attachments to the tank wall, such as the equipment pods, appeared to have no adverse effect on the structural integrity of either the tank skin or the attachment brackets. An example of wrinkling under brackets

Figure 30. - Wrinkling under wiring tunnel - test 3.

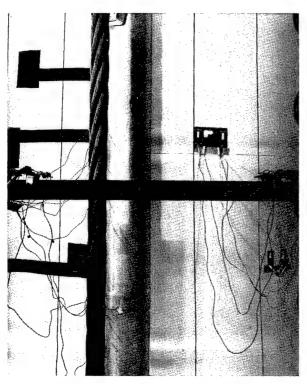
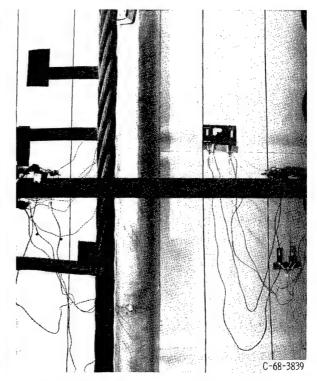
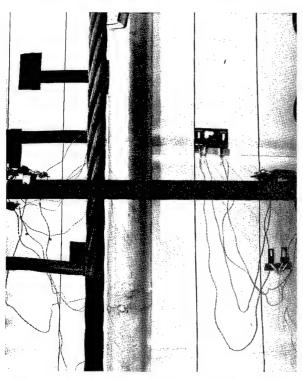
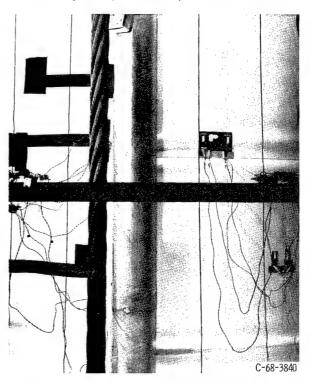
Figure 30. - Concluded.

is shown in figure 30. The reinforcing or stiffening effect of the longitudinal seams in the skins did disturb the predicted wrinkle pattern in the heavily loaded area at station 812. The vertical stiffener created by the longitudinal joint precipitated a discontinuity in the wrinkles as they progressed around the circumference of the tank. This deviation from the predicted behavior is evident in the foreground of figure 28 where the deep wrinkle at station 812 terminated above the circumferential lap joint at the longitudinal joint and shifted down below the lap joint to the less stiff portion of the tank.
